# the LINER LETTER

Volume 3 ~ Issue 5 ~ March 26, 2003

## Folds in PVC Geomembrane

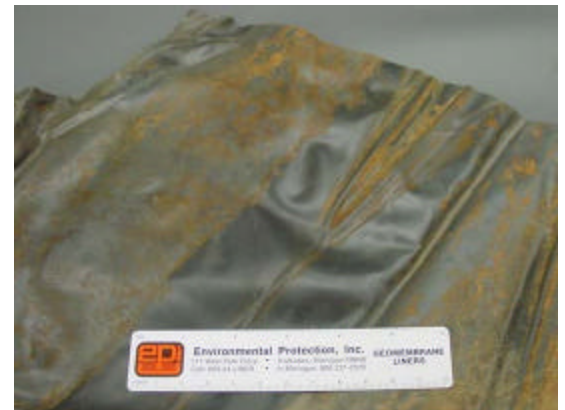
Folds in this liner material have been buried under 12" of sand cover and 10' of water since 1970 (more than 30 years). One sample of material

contained 4 folds in the space of about 1/2" and the material has no sign of failure. Inspection of the material has shown that it is still extremely flexible and there is no evidence of any cracking.

A large number of samples were removed from the test ponds. None showed evidence of failure at folds. At the time of

removal, samples exhibited the same flexibility as "NEW" PVC geomembrane. The flat areas of samples tended to be slightly less flexible after desiccation, but when folds in that material were unfolded, the material protected within the fold still exhibits the same flexibility as PVC liner material produced today!
